Contamination Source Review for Building E3180, Edgewood Area, Aberdeen Proving Ground, Maryland

S.D. Zellmer, M.P. Smits, J. Rueda, and R.E. Zimmerman

September 1995

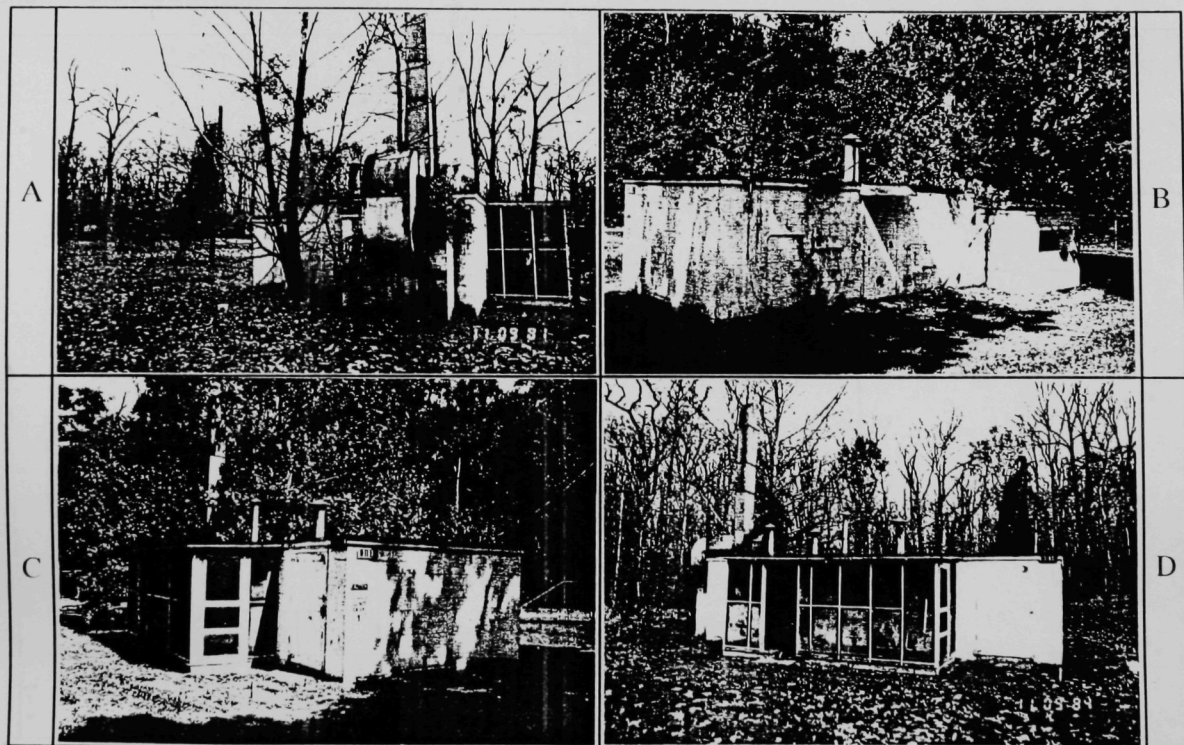
The north side of the building is in good condition, but shows signs of weathering. The sheet metal stack of the ventilation system is rusted.

The east elevation of the building is in good condition, but shows signs of weathering. The electrical conduits are rusted.

The west elevation of the building is in good condition, but shows signs of weathering. There is no door in the porch doorway.

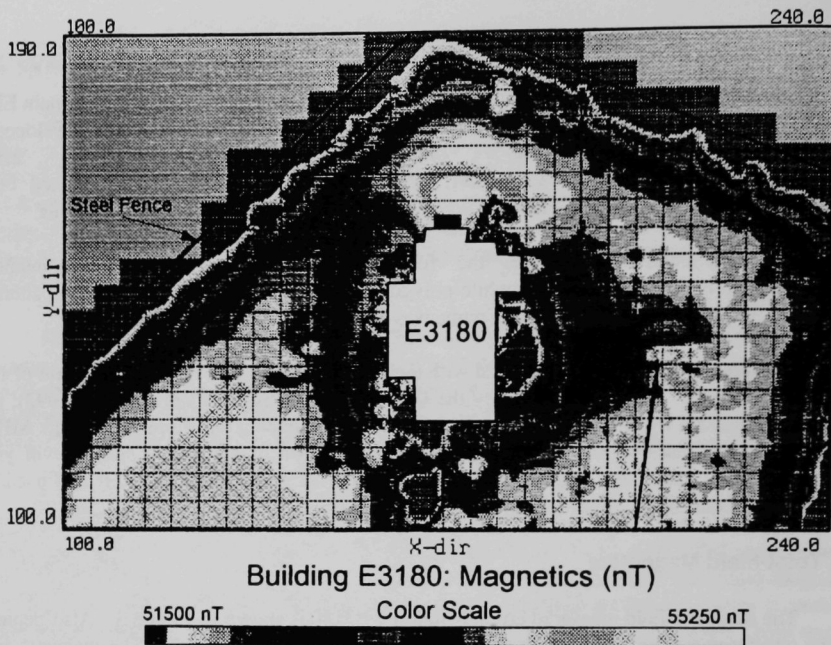
FIGURE 3 Total Magnetic Field Anomaly Map

The magnetic field measured around Building E3180 is shown in Figure 3. Also depicted are the magnetometer profiles, which were run in both x- and y-directions. The magnetic field around Building E3180 is dominated by anomalies caused by the steel fence and the building. Examination of Figure 3 shows that magnetic data within 7 ft of the steel fence cannot be used.

Several other magnetic anomalies are also attributed to features visible at the surface. A 10-ft diameter magnetic high located immediately north of Building E3180 is probably caused by the adjacent metal duct (see Figure 2). The magnetic high/low pair, located at grid coordinates (210, 134), is due to the guy-wire and anchor stake that support the utility pole to the east of the building.

Low magnetic anomalies located adjacent to the building are generally attributed to magnetic material associated with the building structure. The anomaly on the eastern edge of the building, which extends outward nearly 10 ft, may in part be attributed to buried metallic material.

An 8-ft wide magnetic low extends from the southwest corner of Building E3180 and exits the survey area to the south. The northern half of this anomaly is spatially located over a cluster of stone/cement slabs that presumably once formed a sidewalk. The southern half of the anomaly may be caused in part by a continuation of this walkway. However, the anomaly is also adjacent to a vertical pipe that is located at grid coordinates (165, 115) (shown in Figure 2); the anomaly may be caused by a buried metallic object associated with the pipe.

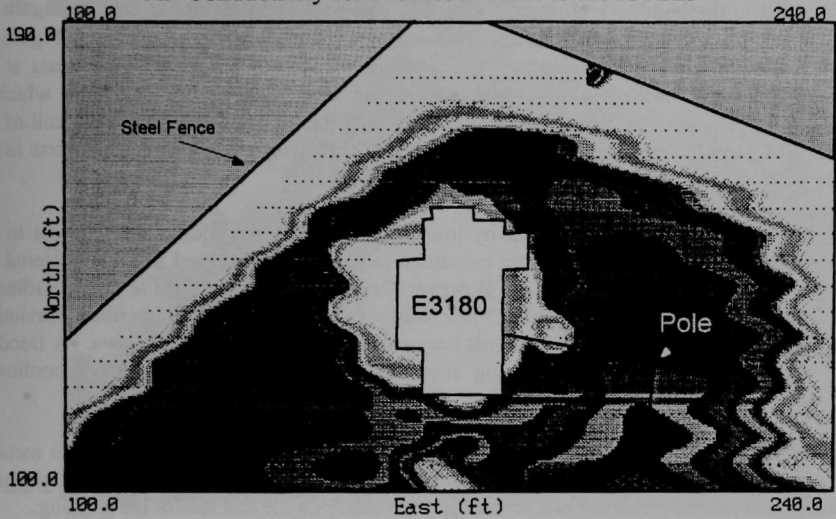
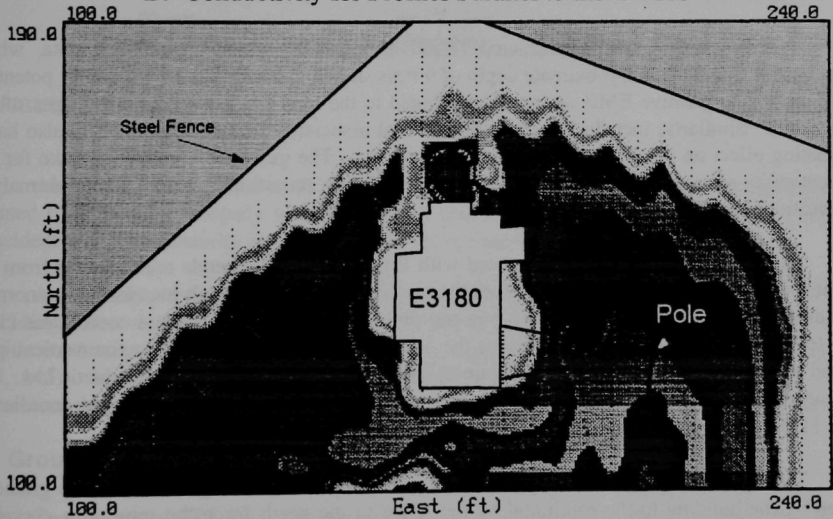
FIGURE 4 Terrain Conductivity Anomaly Map

Figure 4 shows the mean electrical conductivity for the upper 20 ft of sediment around Building E3180. Figure 4A shows a color map derived from profiles conducted parallel to the x-axis, while Figure 4B shows a color map derived from profiles conducted parallel to the y-axis. The data were contoured using a contour interval of 2 mS/m. As with the magnetic anomaly map, the effects of the steel fence dominate much of the figure, and conductivity data acquired within 15 ft of the fence line are not usable.

A conductivity low centered at grid coordinates (170, 162) is probably due to the metal duct attached to the building's northern wall. The east-west-oriented profile data in Figure 4A along $y = 160$ ft do not show such an anomaly; only the perpendicular profile data in Figure 4B along $x = 170$ ft show the low anomaly. The apparent discrepancy of conductivity values at the intersection of the two traverses is due to the orientation of the Geonics EM-31 boom, which is always carried parallel to the direction of the profile during the survey. The transmitter coil of the Geonics EM-31 boom came in proximity to the metal duct during the north-south traverse in the vicinity of the two perpendicular profiles.

The complex pattern of conductivity lows southwest of the building and adjacent to the southern border of the survey area might be caused in part by gravels used as grade material for the adjacent access road to the building. However, the strongest low, located at grid coordinates (175, 100), overlaps the strong magnetic low southwest of the building described previously (Section 3.1; see Figure 3). The cause of this low conductivity anomaly is not known. A trend of positive conductivity anomalies extending southwest from the building to grid coordinates (150, 105) may be related to the same source.

High conductivities immediately adjacent to the building are primarily attributed to metallic material associated with the building structure. Like the magnetic data, however, the anomalies may be caused partly by buried metallic sources, particularly on the east side of the building.

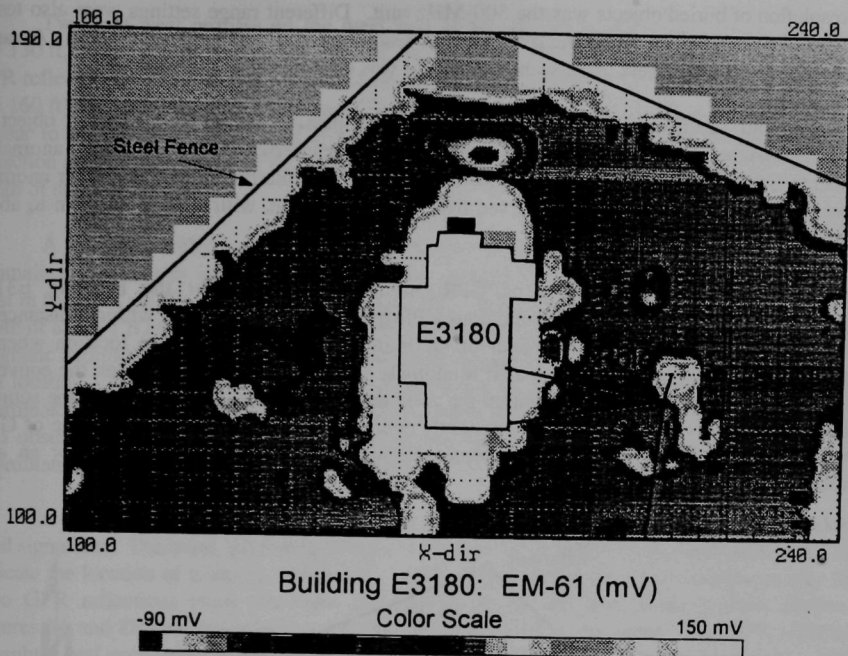
FIGURE 5 EMF Anomaly Map

A color-contour map constructed from the Geonics EM-61 lower coil data, which represents all signal to an approximate depth of 9 ft, is shown in Figure 5. As with other potential-field data, strong positive EMF anomalies attributed to the steel fence dominate the edges of the survey area. Similarly, metallic construction material associated with Building E3180 also had a dominating effect on data collected close to the building. The guy-wire and anchor stake for the adjacent utility pole at grid coordinates (210, 130) probably caused the positive EMF anomaly at that location, just as it did for magnetic data.

The strong EMF anomaly associated with Building E3180 extends relatively far from the building, both from the south wall and from the southwest corner. In both locations, the anomaly extends more than 10 ft from the building in proximity to the EMF anomaly at coordinates (162, 102) (discussed below). The anomaly at the southwest corner is adjacent to the vertical pipe located at grid coordinates (165, 115) (Figure 2) and is coincident with a strong magnetic low. The anomaly at the south wall is coincident with the isolated magnetic high located at grid coordinates (170, 112). The sources of the anomalies are unknown.

The low anomaly immediately north of the building is a gridding artifact. Steep gradients caused by the building to the south and by the fence to the north force the minimum curvature algorithm to calculate a false anomaly. Neither east-west profiles along $y = 160$ ft nor the profiles along $y = 180$ ft exhibit a strong conductivity low.

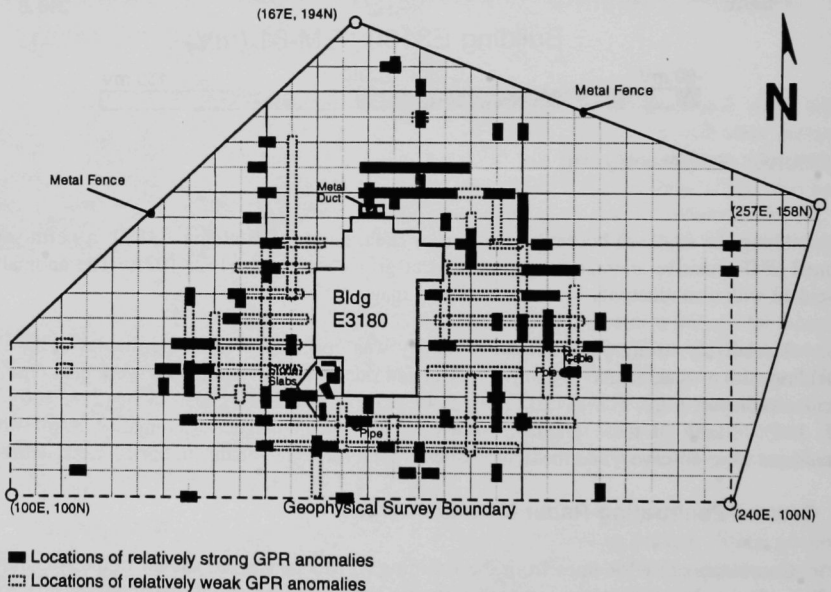
FIGURE 6 Locations of Anomalous GPR Reflectors for Building E3180

Figure 6 shows a summary of GPR anomalies observed for the Building E3180 geophysical survey area. A zone of anomalous GPR reflections was observed within a distance of about 35 ft around much of the perimeter of the building. Generally, at each location where a potential-field anomaly was observed, a GPR anomaly was also observed. However, the converse was not always the case, particularly within the zone described above, suggesting that the sources of many of the GPR reflections are predominantly nonmetallic in composition. The zone of GPR reflections around the building probably represents an area of disturbed sediments or an area covered with sedimentary fill material.

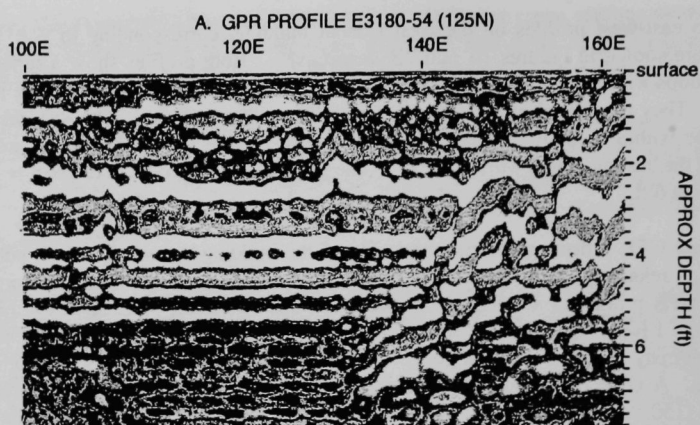
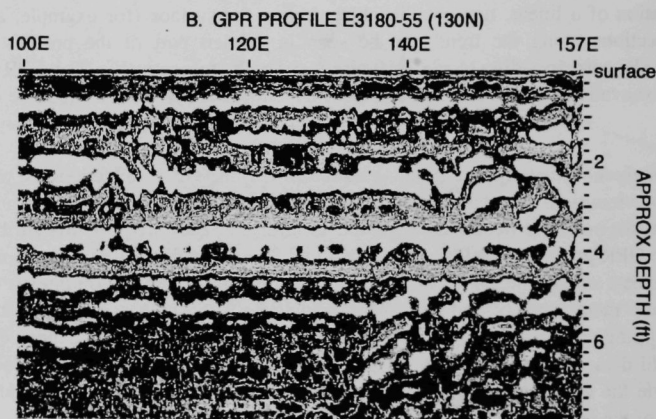
FIGURE 7 Two Adjacent West-to-East GPR Profiles on West Side of Building E3180

Two east-west profiles on the west side of building, corresponding to $y = 125$ ft and $y = 130$ ft, are shown in Figures 7A and 7B, respectively. Both profiles show a series of strong GPR reflections within the zone described above, located between $x = 140$ ft and the building (at $x = 160$ ft). They are typical of adjacent GPR profiles on the west side. The strongest reflectors appear to be within a depth range of 1.0-2.5 ft. Both profiles also show an apparent dipping reflection at the leading edge of the anomaly. The reflection is observed at about $x = 138$ ft, at a depth of about 6 ft.

A few GPR reflections on the west side of the building do coincide with potential-field anomalies. A relatively isolated, but nevertheless strong, GPR reflection is also observed further west in the GPR profile for $y = 125$ ft (Figure 7A). The reflection, centered at $x = 130$ ft, has a depth of about 1 ft and is coincident with a strong EMF anomaly (Figure 5) and a relatively high magnetic anomaly (Figure 3). The source of the anomalies is probably a buried metallic object at that location. A GPR reflection (Figure 6) corresponds to the magnetic anomaly located at grid coordinates (150,110) and also probably indicates a buried metallic object. Magnetic anomalies are also observed within the zone of GPR reflections near the west side of the building at grid coordinates (140,130) and (145,135) (Figure 6).

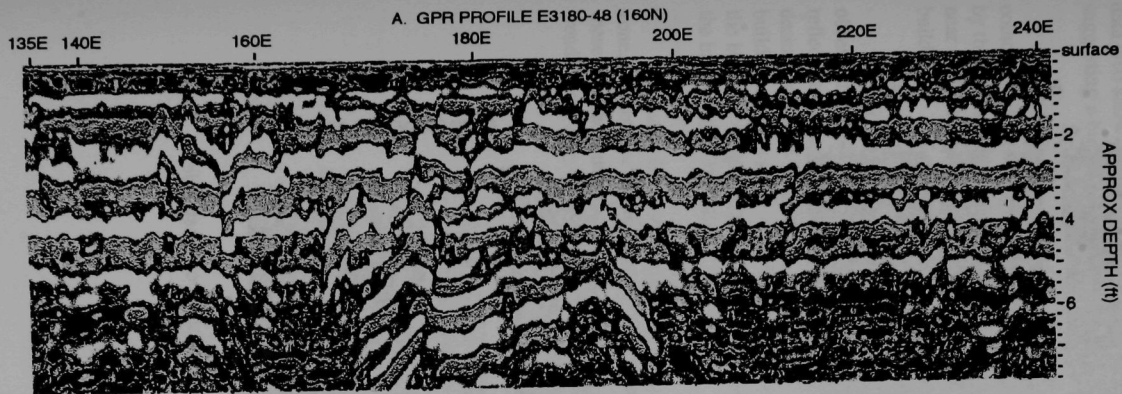
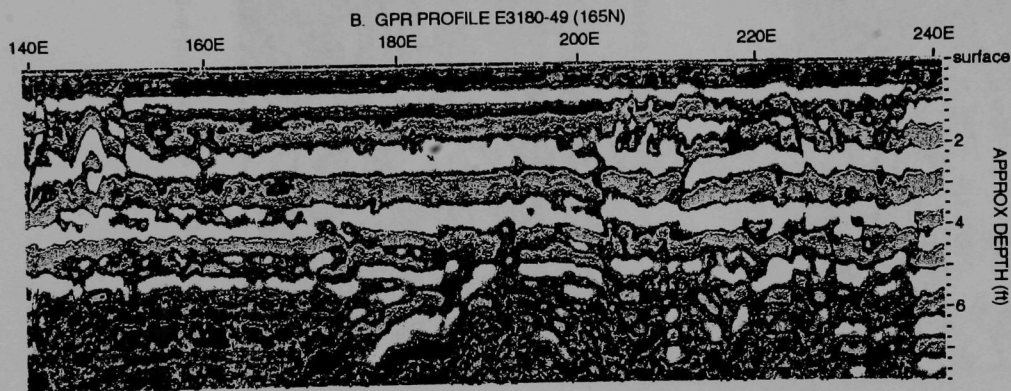
FIGURE 8 Two Adjacent West-to-East GPR Profiles on North Side of Building E3180

Immediately north of the building, the zone of strong GPR reflections is pronounced, particularly in the vicinity of a metal duct centered at grid coordinates (170, 155). Anomalies are observed in all of the potential-field data sets at this location, and they are primarily attributed to the metal duct. The GPR profiles shown in Figures 8A and 8B continue east immediately north of the metal duct to the east side of the survey area. Both profiles show reflections dipping to the west in the vicinity of the metal duct ($x = 170$ ft) and dipping back to the east further east along the profiles. The dipping reflections have a depth of about 4-5 ft. Unlike the anomalies delineated by the potential-field data, the GPR anomalies continue nearly 25 ft east of the metal duct to about $x = 200$ ft. While the GPR anomalies may be caused partly by buried objects, they are probably more indicative of the lateral extent of ground disturbance near the building.

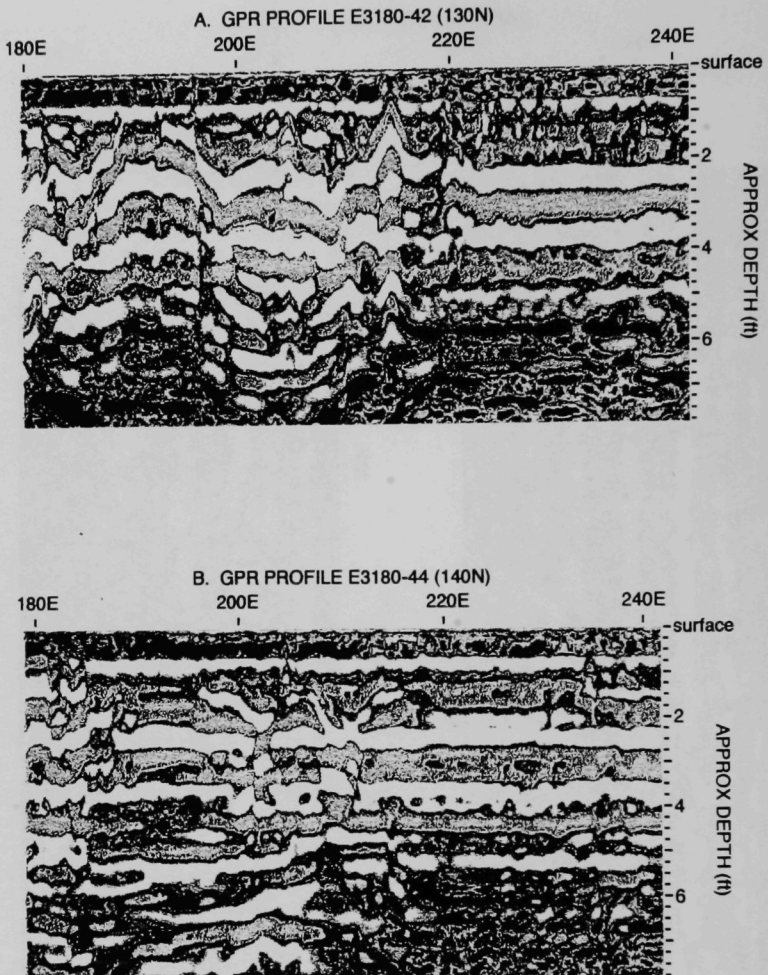
FIGURE 9 Two Nearly Adjacent West-to-East GPR Profiles on East Side of Building E3180

Two east-west profiles on the east side of building are shown in Figures 9A and 9B, corresponding to $y = 130$ and $y = 140$ ft, respectively. As with profiles on the west side of the building, the profiles at the east side show a series of strong GPR reflections within the anomalous zone close to the building, located between the building ($x = 180$ ft) and $x = 220$ ft. The strongest reflectors appear to be within about 2 ft of the surface. Adjacent and north-south profiles are similar in character within the anomalous zone.

The strong reflection at about $x = 215$ ft in Figure 9A may be caused by the steel cable supporting the utility pole at grid coordinates (210, 125). However, the cable intersects the ground at grid coordinates (210, 130), whereas the GPR reflection is 5 ft further east. Magnetic and EMF data also show anomalies at the location of the GPR anomaly, at about grid coordinates (215, 130), suggesting a buried metallic source.

GPR reflections within about 10 ft of the building in Figures 9A and 9B ($x = 180$ -190 ft) coincide with a strong negative magnetic anomaly. The GPR reflections are somewhat distorted by the building; they do not suggest the presence of any large, metallic objects below the surface near the building. The magnetic anomalies are probably caused by metallic material in the building.
